Stability of a Thin-Walled Silo Hopper – Case Study

Peter Knoedel

The paper presents a case study on an ensemble of four 60 m high, 8 m diameter concrete silos with steep steel hoppers of 10 mm / 8 mm wall thickness. A circumferential weld of one of the hoppers failed after some 6 months of operation.

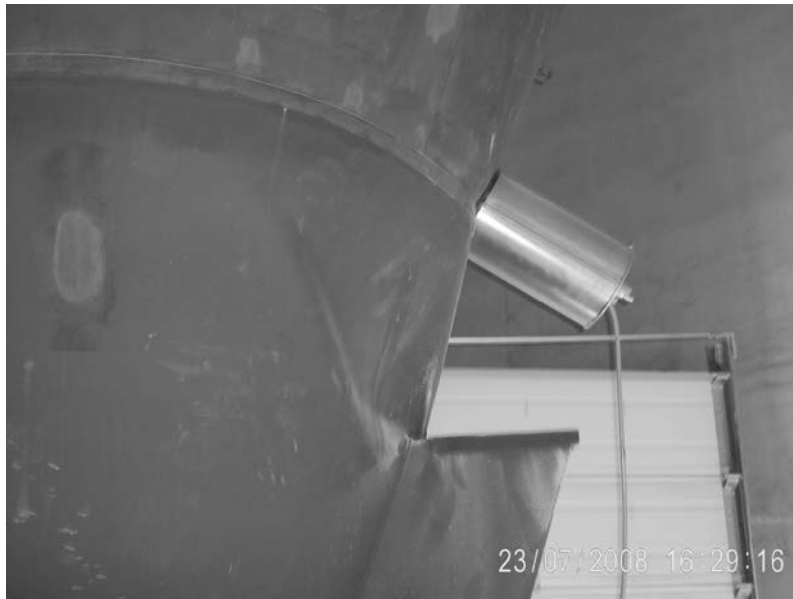
Figure 1: Deformation of the hopper without subsequent failure (project anonymous) (photograph: P. Knoedel 2008)

However the deformations which were observed several weeks before failure and the type of failure itself supported the assumption, that ovalisation of the hopper occurred at first and subsequently caused local overloading of the hopper wall and triggered failure of the weld. On the above photographs (**Figure 1** and **2**) one of the silos is shown, that had typical deformations but did not fail.

- The inclined fold at the top corner of the outlet box (see **Figure 1**) could not be obtained as a result of the calculations. Maybe modeling the outlet box with vertical faces along a meridian instead of parallel turns out to be an unsuitable simplification. This seems to require more thorough investigations.

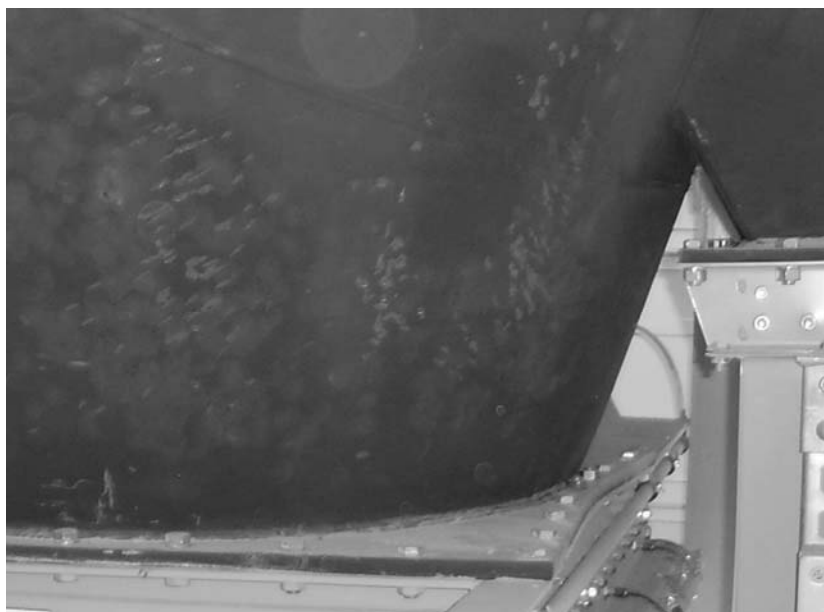
Figure 2: Deformation of the outlet plate without subsequent failure (project anonymous) (photograph: P. Knoedel 2008)

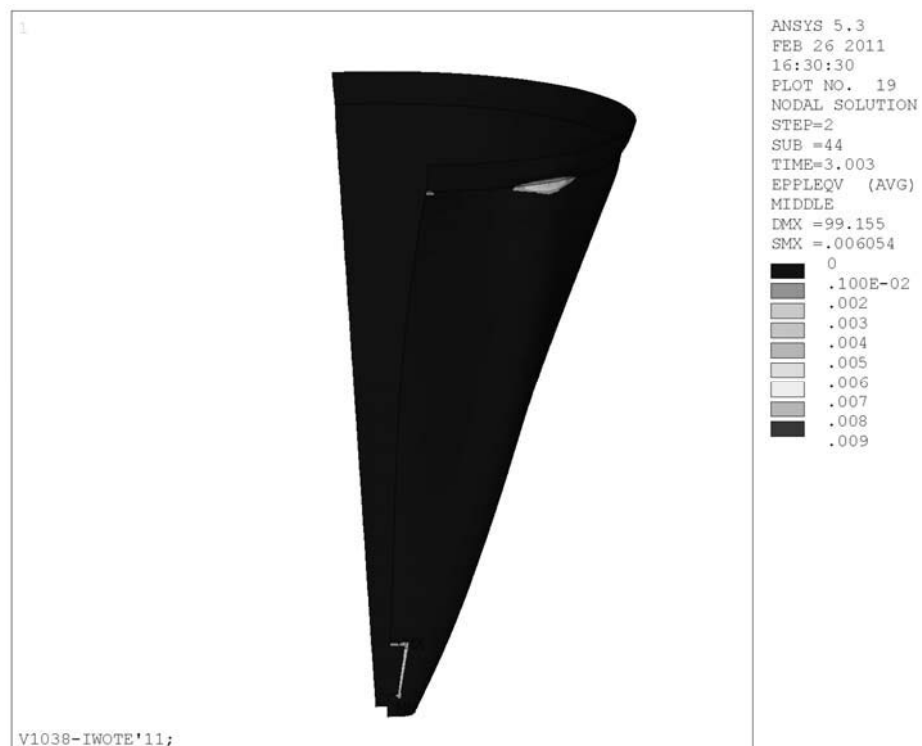
Figure 17: Plastic equivalent membrane strain at 200 % filling load

The critical part seems to be the top edge of the cone, where progressive membrane yielding is indicated (see **Figure 17**). The bending stresses at both surfaces of the shell as well as plastic surface bending strains (not documented in this paper for space restrictions) are by a factor of 2 higher at least. Usually in thin-walled shell design bending stresses are not a big issue, since overloading yields off bending stresses and after performing the necessary large radial deformations the shell structure arrives at a new and robust membrane state.

In the present case, were a faulty weld at the top supporting ring is in discussion, the described stress-and-strain state could very well explain the failure of the weld.
